CONDITION REPORT

GERFALCON

Dated 2nd January 2021

Client: Mr S Hurrell

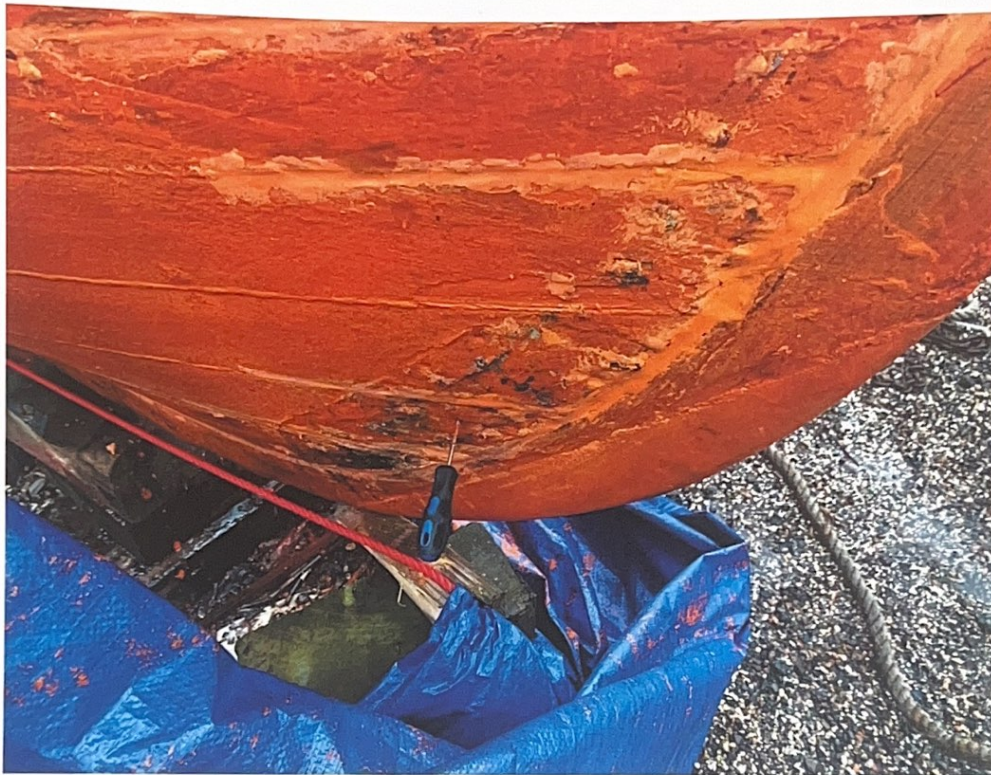
There was some soft rot noted in way of the hooded ends and deadwood.

We would recommend that any rot below the waterline be dealt with at this time and that the rot above water be dealt with at the owner's convenience.

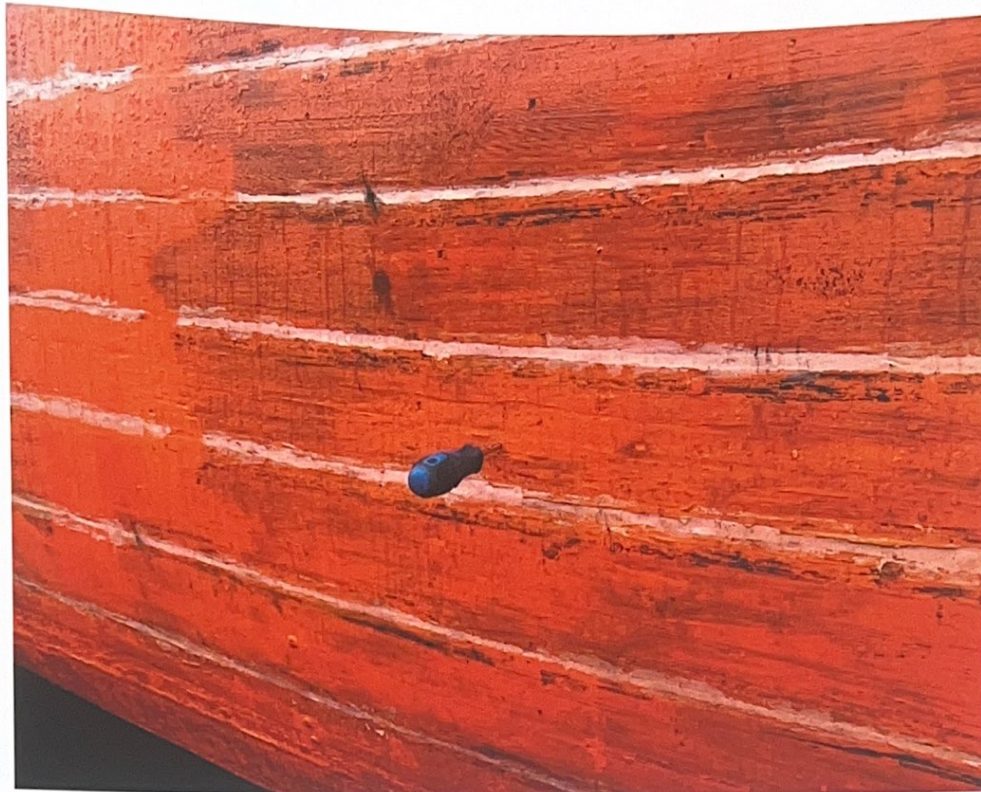
There was a small area of soft rot noted on the port side above the waterline.
