## VESSEL CONDITION REPORT

GERFALCON

Mr G Fletcher

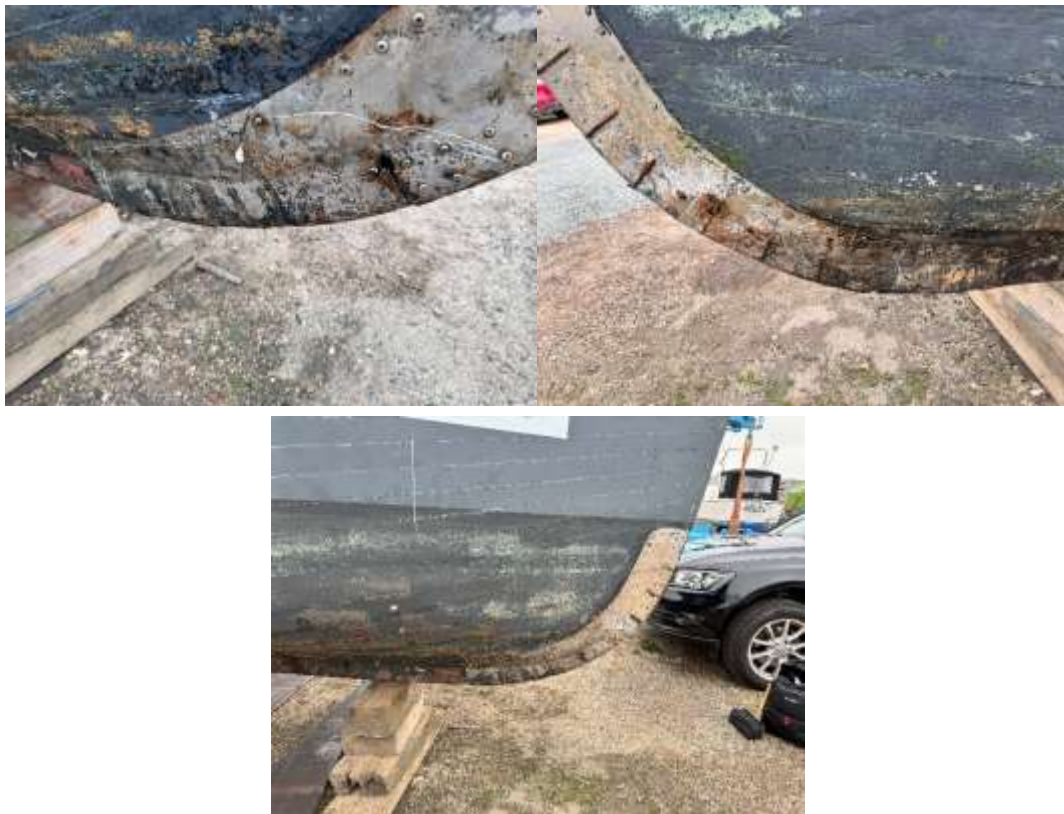
The stem and stem band, gripe, keel, sternpost and horn timber were all examined, hammer and prick tested and found in generally good condition but with some areas of soft rot noted. The stem had previously been noted to have some rot in way of the hooded ends and a stainless-steel cover had been screwed into the surrounding area, the stainless steel had corroded excessively.

*We would recommend that this is carefully removed and the area beneath assessed.*

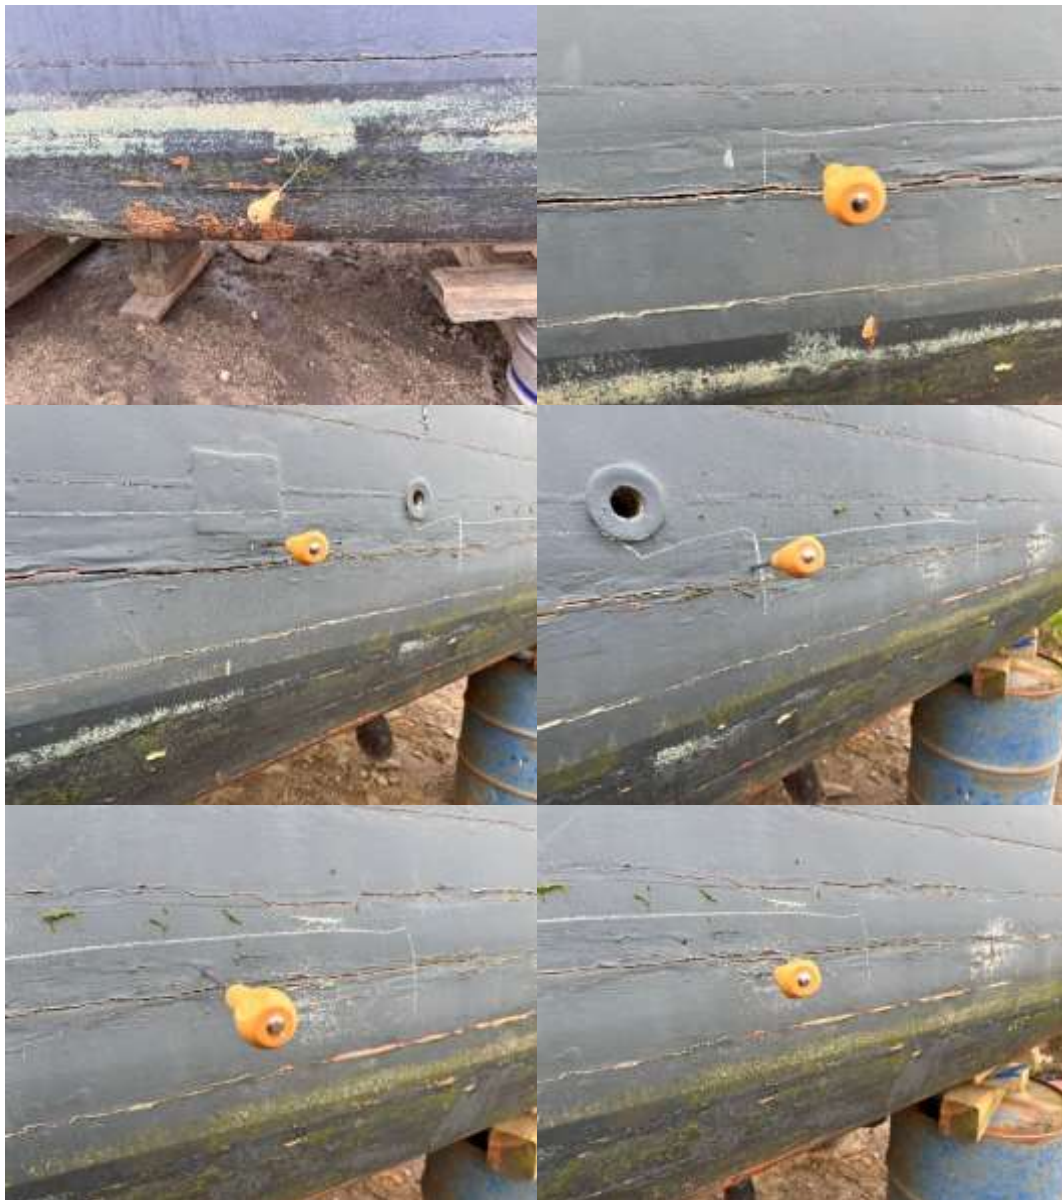
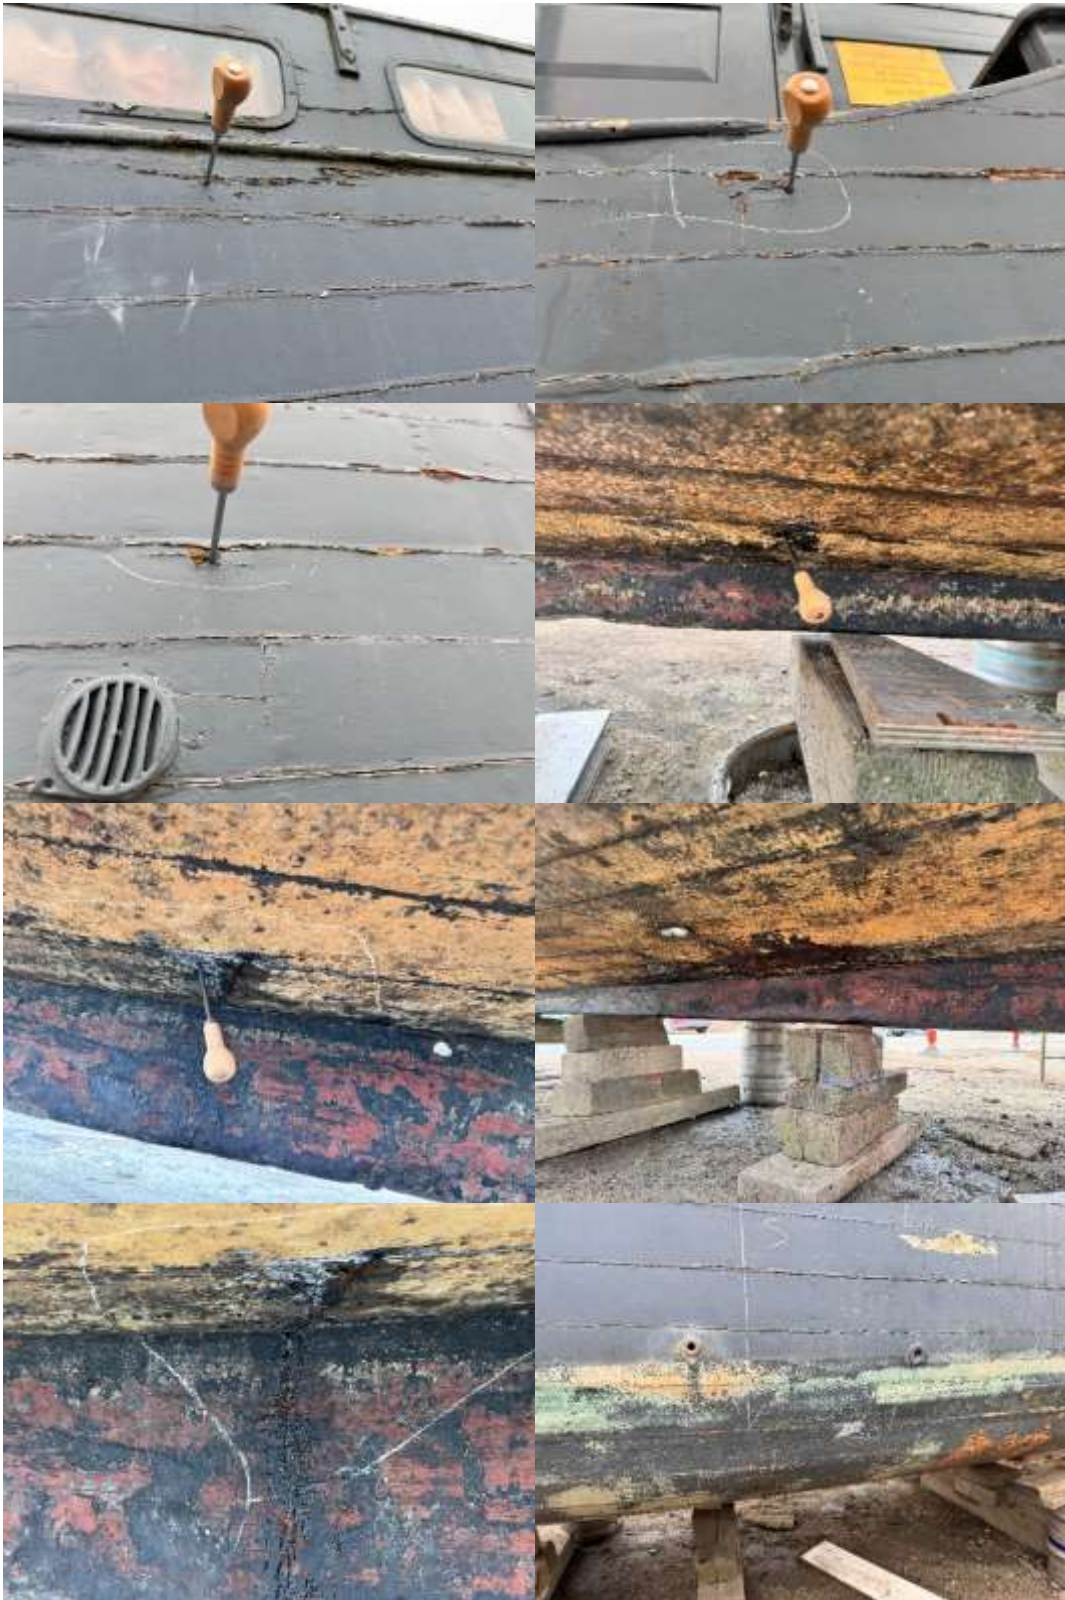
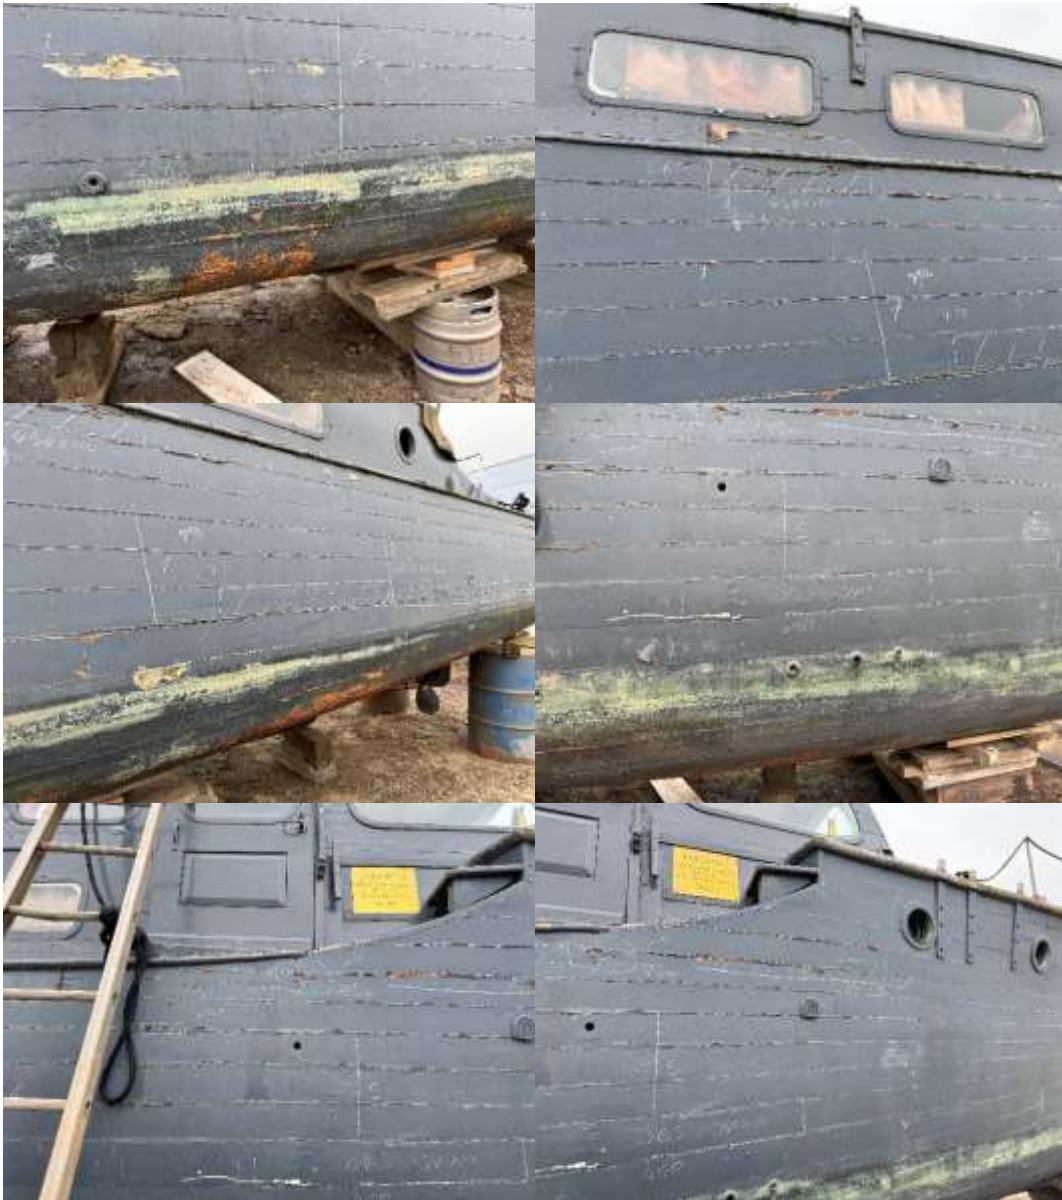
The rest of the bottom and topsides were found with the following areas of rot.

Below Waterline	5000 mm from stem	Fastening
Below Waterline	1700 mm from stem	300 mm x 100 mm
Above Waterline	4000 mm from stem	890 mm x 75 mm
Above Waterline	4500 mm from stem	750 mm x 100 mm
Above Waterline	5100 mm from stem	200 mm x 200 mm
Above Waterline	6700 mm from stem	70 mm x 110 mm

Numerous seams had opened up on the topsides and the white cotton caulking had caused damage to the plank edges.

*We would recommend that the areas of rot are cropped out and renewed and that the caulking be removed and an alternative and more gentle means of sealing the seams be implemented.*

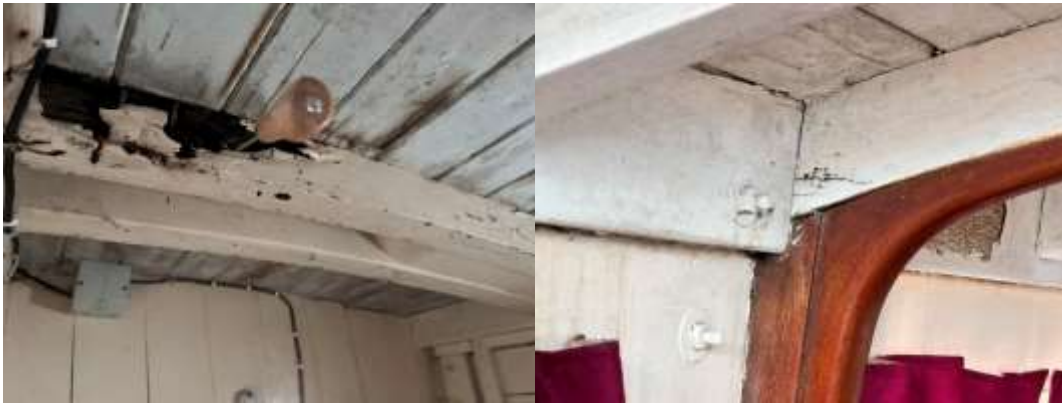
Two deck beams were found soft rotted and in need of renewal or repair.

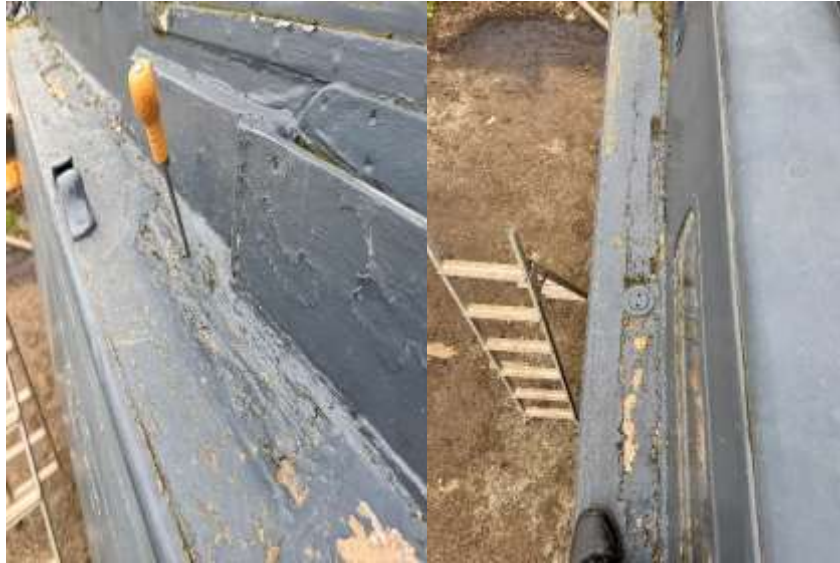
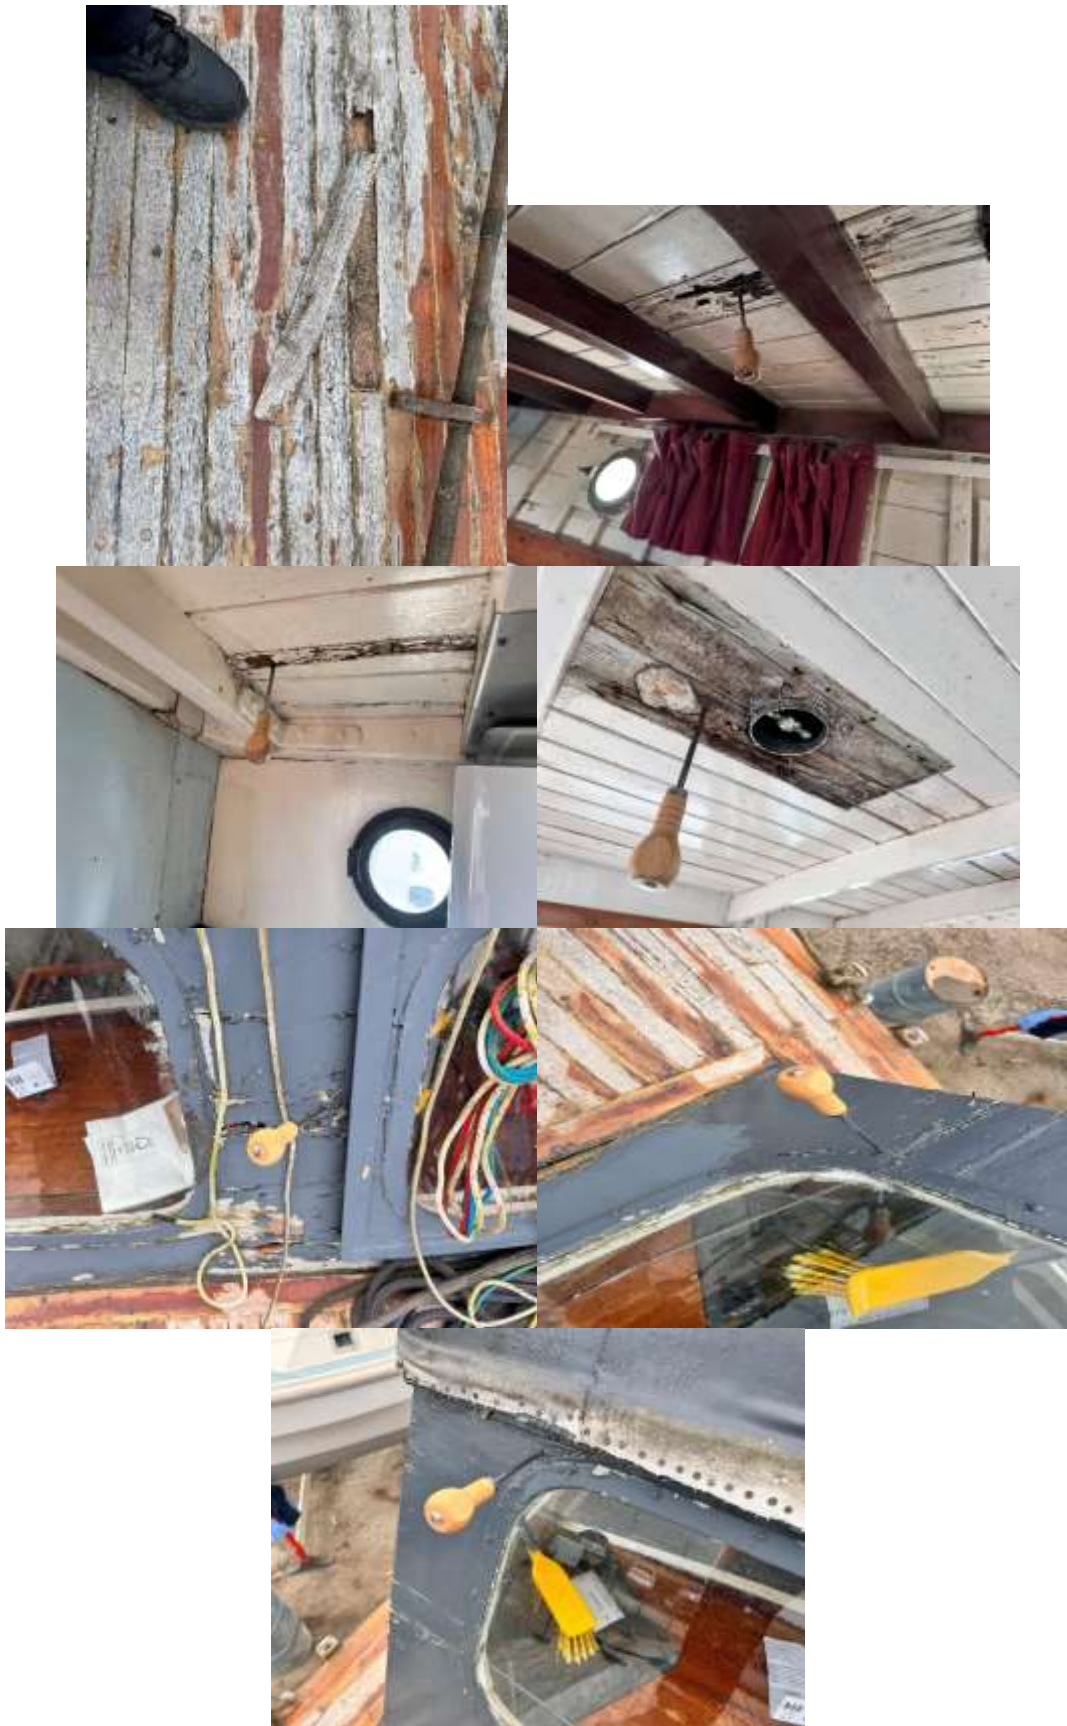
*The deck and superstructure were of teak or plywood and were found to be heavily soft rotted and we would recommend that they be renewed entirely.*

The after cockpit recess housings were found with the lids soft rotted and in need of renewal.

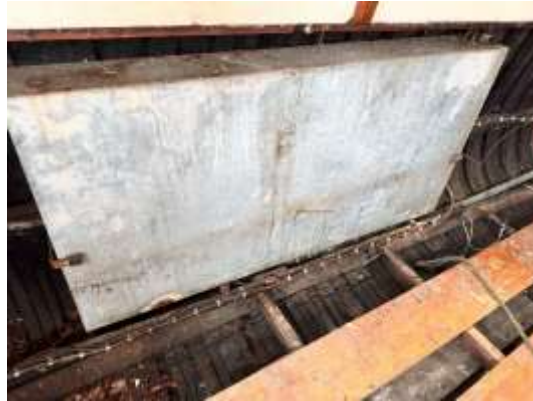
*The tanks were examined as far as possible in situ and found in good order, access to the back and bottom of the tanks was limited and the condition of these areas cannot be guaranteed, however there is some corrosion present on the bottom of one tank and we would recommend that they be pressure tested.*
