CONDITION REPORT

GERFALCON

Dated 2nd January 2021

Client: Mr S Hurrell

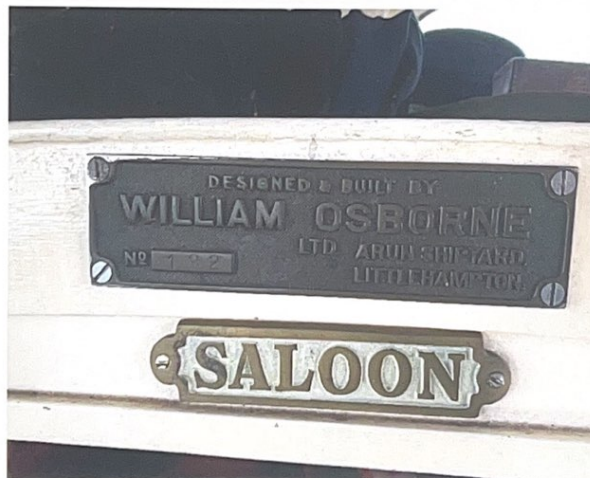
3.4 Builders and Date of Build.

According to the original registration document the vessel was built in by W.M. Osborne Ltd of Arun Shipyard, Littlehampton in 1937 as yard number 192. The vessel had a Builder's Plate but we have not checked these particulars and cannot guarantee their accuracy.
