## VESSEL CONDITION REPORT

GERFALCON

Mr G Fletcher

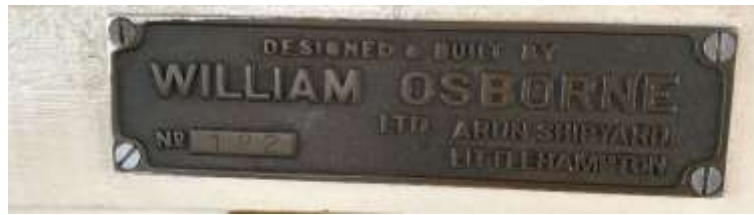
According to the original registration document the vessel was built in by W.M. Osborne Ltd of Arun Shipyard, Littlehampton in 1937 as yard number 192. The vessel had a Builder's Plate, but we have not checked these particulars and cannot guarantee their accuracy.
